JANES CREEK WATERWAYS - TREATMENT CHAIN WETLANDS

A case study of Partnership and Revegetation

Central Queensland Coast, Mackay

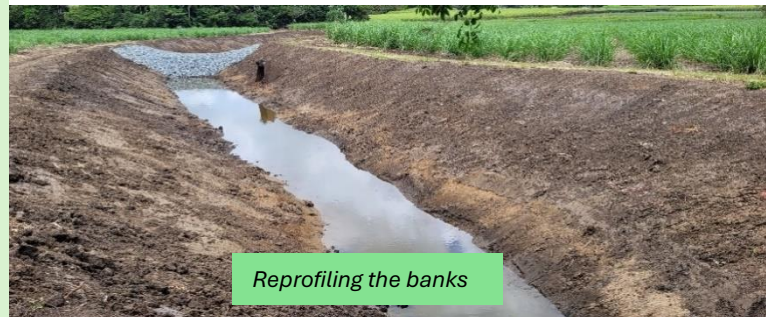
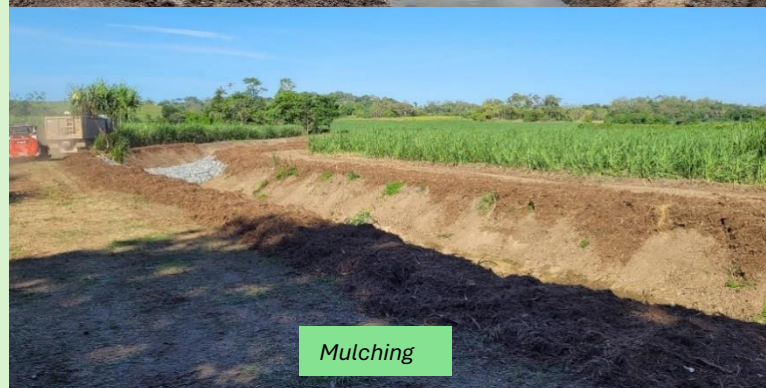
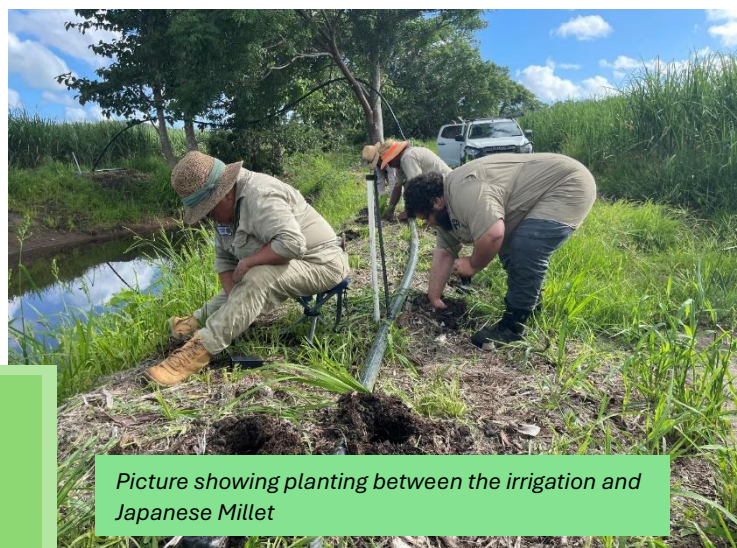
RC completed streambank and gully remediation, which involved engineered design and reconstruction including:

- **Bank Battering:** Constructing protective structures along the streambanks.
- **Rock Groynes:** Installing rock structures perpendicular to the stream to control water flow.
- **Rock Chutes:** Creating channels with rocks to manage water velocity.
- **Soil Removal:** Removing existing soil to prevent weed germination after soil disturbance.
- **Deep Water Holes:** Excavating deep water pockets separated by rock barriers. Silt removed from site was added to adjacent low lying cane paddocks to improve productivity.

- **Site preparation** – mulch and installation of irrigation system.
- **Revegetation** – planting 2700 native tube stock.
- **Maintenance** – manual and chemical treatment of weeds and nuisance grasses. Support tree health and vitality.

Japanese Millet was sown to give quick ground coverage and help stabilise the banks. However, it quickly outgrew the native plants and had to be brush cut.

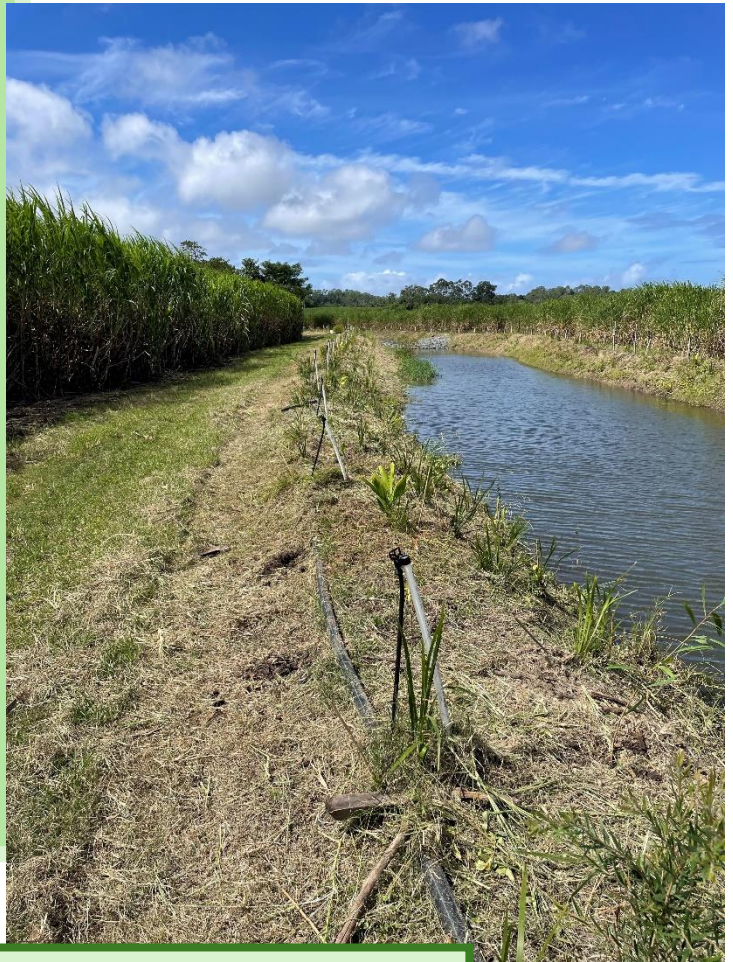
Due to an extended wet season, planting activities and site access were restricted, resulting in a setback. However, all plants were successfully in the ground by mid-March. Over the first three months, these plants have become well established. Irrigation and site maintenance will continue until late June 2024, at which point the landholder will take over stewardship of the site.

The site's riparian structure and connectivity play a crucial role as a buffer, capturing overland flow sediment from cane fields during flood events and reducing sediment loss. Ongoing revegetation efforts and weed control are expected to enhance the diversity and cover of native vegetation, improving bank stability and resilience to future extreme events.
